Aviation Investigation Preliminary Report

Location:	Boca Raton, FL	Accident Number:	ERA25FA173
Date & Time:	April 11, 2025, 10:23 Local	Registration:	N8930N
Aircraft:	Cessna 310R	Injuries:	3 Fatal, 1 Minor
Flight Conducted Under:	Part 91: General aviation - Personal

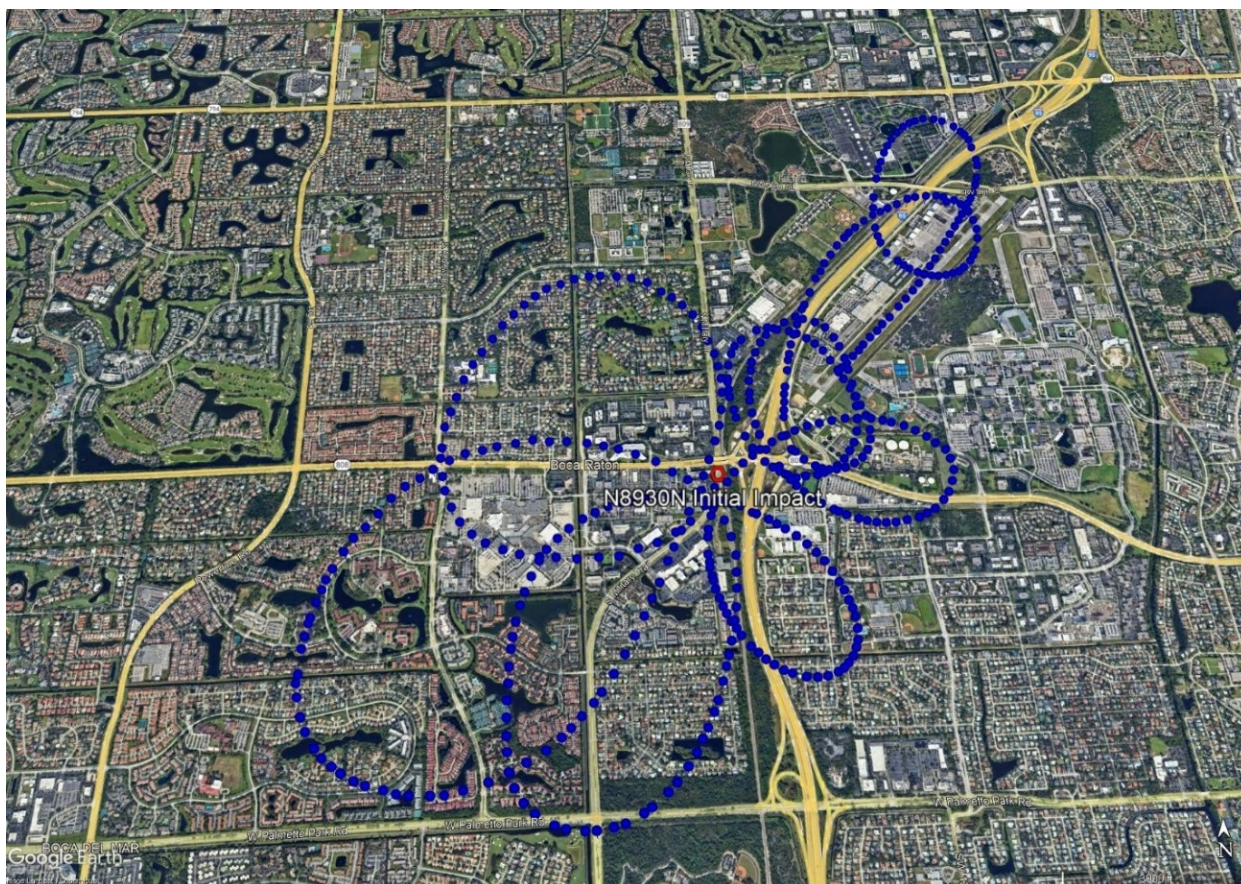
Preliminary ADS-B data revealed that immediately after takeoff, at 1012, the airplane drifted to the left, followed by a left 180° turn, followed by a left 360° turn. The airplane continued making several left 360° turns; the last data point was on the airplane's 9th turn at 1022 and was 273 ft south of the initial impact point. According to preliminary air traffic control recordings, one of the pilots reported that they were having a problem with the airplane's rudder and that they could only make left turns.

Figure 1. Preliminary ADS-B Flight Track with initial impact point marked.
