# National Transportation Safety Board Aviation Accident Preliminary Report

Location: Wayne, NE Accident Number: ERA22FA233

Date & Time: May 20, 2022, 18:42 Local Registration: N76075

Aircraft: Cessna 140 Injuries: 1 Fatal

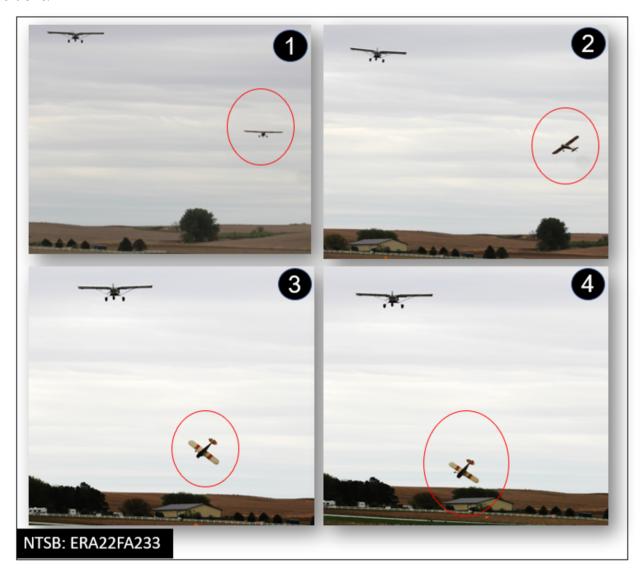
According to multiple witnesses and video/photographic evidence, the accident airplane was the last airplane within the group of 5 and two landings had been performed without incident. During the third approach with the accident airplane on final approach and following a Zenith STOL 701 also on final, the accident airplane descended and appeared to be lower than the airplane ahead. Subsequently, the pitch attitude increased, the airplane rolled to the right, and completed a 3/4 turn right spin and impacted terrain in a near vertical attitude, as shown in Figure 1 with the accident airplane circled in red.

The STOL Drag representative that coordinated the pattern operations over the radio reported that about 45 seconds prior to the accident, he stated over the radio to the accident pilot, "lower your nose you look slow." About 15 seconds before the accident, he stated again to the

accident pilot, "lower your nose." There were no communications received from the accident pilot and none of the other pilots in the pattern were talking on the radio near the time of the accident.

Figure 1: Four photographs showing the right roll and descent
