## National Transportation Safety Board Aviation Accident Preliminary Report

<b>Location:</b>	Freeland, WA	<b>Accident Number:</b>	DCA22MA193
<b>Date &amp; Time:</b>	September 4, 2022, 15:09 Local	<b>Registration:</b>	N725TH
<b>Aircraft:</b>	DEHAVILLAND DHC-3	<b>Injuries:</b>	10 Fatal
<b>Flight Conducted Under:</b>	Part 135: Air taxi & commuter - Scheduled

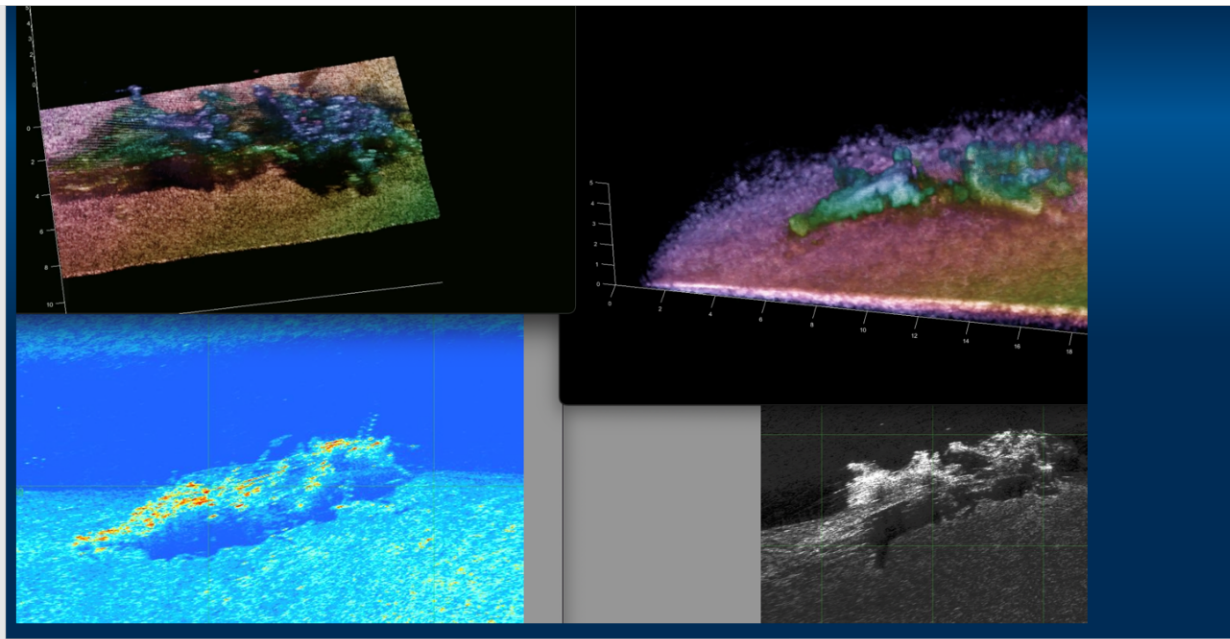
A sonar survey of the accident area located the main wreckage and debris field at a depth of about 190 ft.

Figure 3: Images from University of Washington Applied Physics Lab Multi-Sensor Towbody (MuST) – including 3D processed data of main wreckage
