Aviation Investigation Preliminary Report

Location:	Houston, TX	Accident Number:	DCA24FA120
Date & Time:	March 8, 2024, 07:58 Local	Registration:	N27290
Aircraft:	Boeing 737-8	Injuries:	166 None
Flight Conducted Under:	Part 121: Air carrier - Scheduled

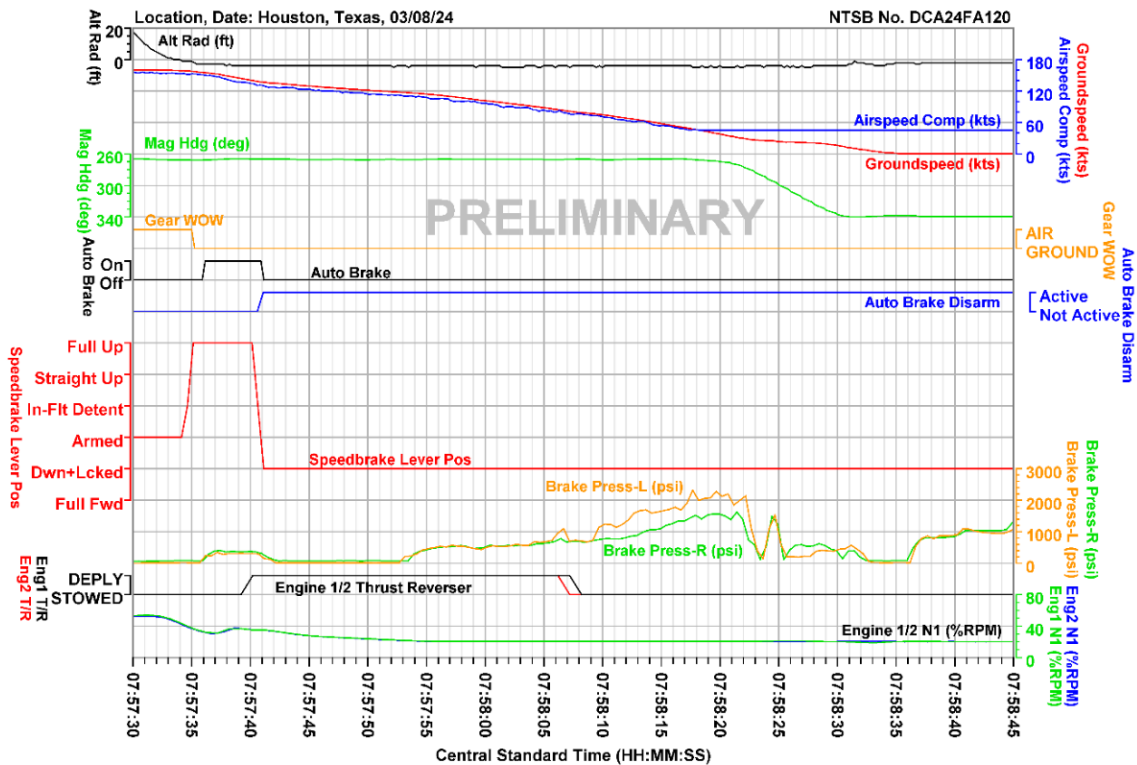
Data from the DFDR was sent to the NTSB’s Vehicle Recorder Laboratory in Washington, DC, for analysis. A preliminary review of data has been completed and a plot showing the braking parameters is shown in figure 3. Data showed that at touchdown the speed brake lever position [Speed Brake Lever Pos] and auto brake parameters were full up and on for about 5 seconds before transitioning to down and locked and off for the remainder of the landing rollout.

The engine thrust reversers were deployed for the left and right engines for about 27 and 26 seconds respectively at idle reverse. The left and right brake pressure increased to their maximum pressure consistent with aggressive manual braking before and as the airplane’s heading changed consistent with a right turn.

Figure 3. Plot of the FDR data from the accident landing.
