# Aviation Investigation Preliminary Report

| <b>Location:</b> | Jersey City, NJ | <b>Accident Number:</b> | ERA25MA171 |
| <b>Date &amp; Time:</b> | April 10, 2025, 15:15 Local | <b>Registration:</b> | N216MH |
| <b>Aircraft:</b> | Bell 206L-4 | <b>Injuries:</b> | 6 Fatal |

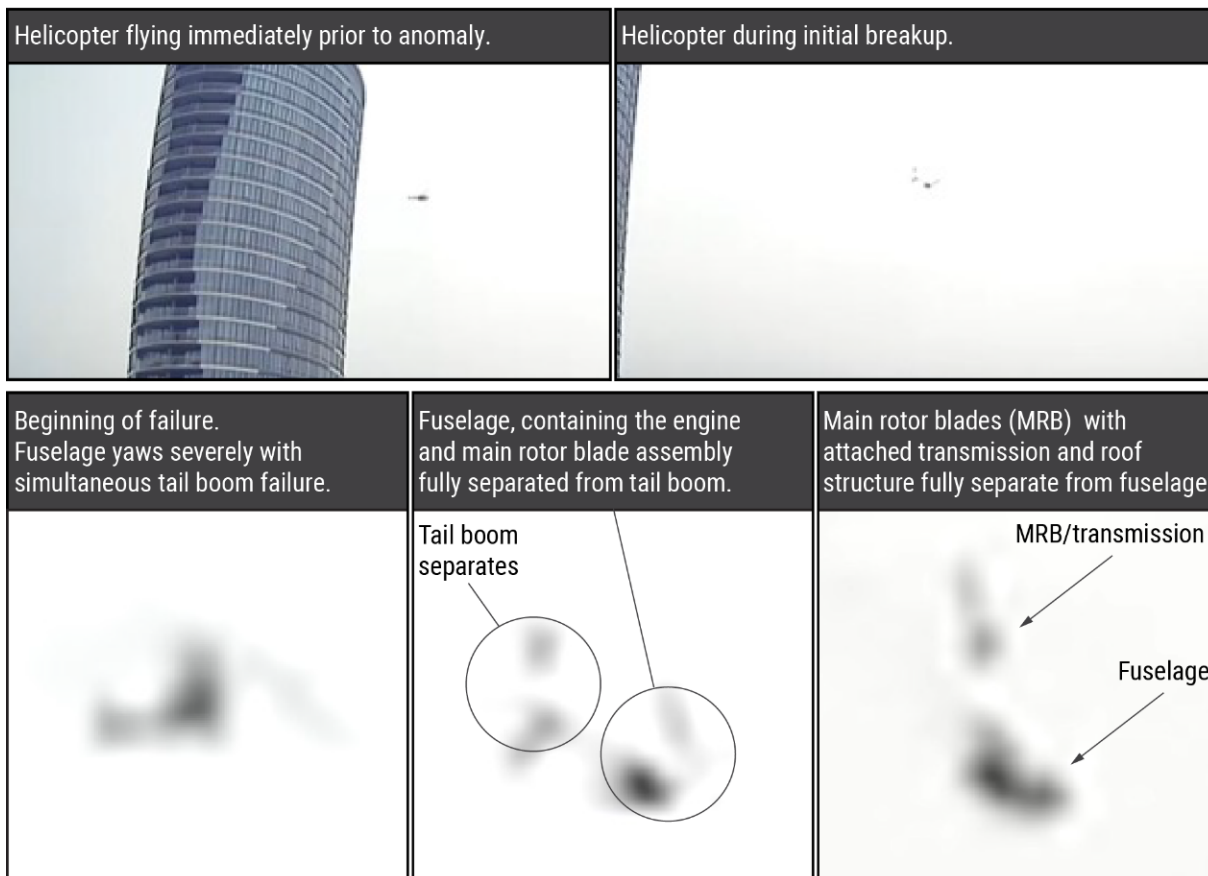
**Figure 3. Enhanced surveillance video with sequential images depicting the helicopter's flight and breakup.**

Several witnesses described hearing several loud “bangs” emanating from the helicopter before it broke up and descended into the river. Surveillance video (with accompanying audio) captured the helicopter traveling south before it suddenly separated into three major sections: fuselage (including the engine), main rotor system (including both main rotor blades, transmission and roof-beam structure), and the tail boom (including the tail rotor) (figure 3).
